CORNER RECORD

Document Number 2015-2275BCity of TUSTIN County of ORANGE, CaliforniaBrief Legal Description ORANGE KNOLL DRIVE & GATEWAY DRIVE

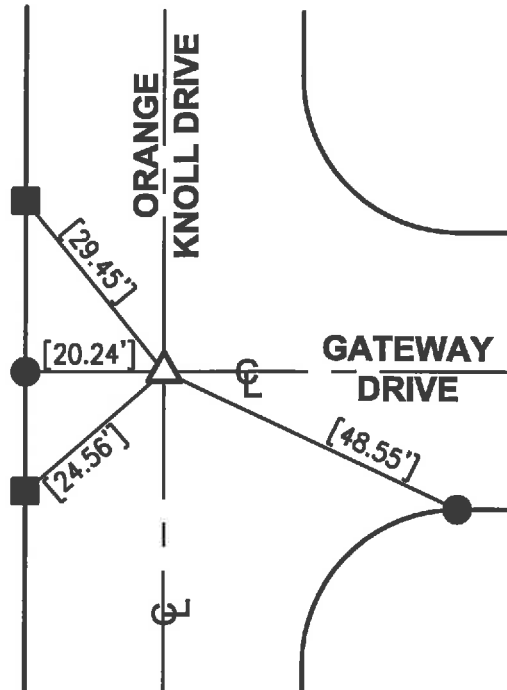
R-1 = COUNTY OF ORANGE CORNER RECORD 2015-2222 A
 [] = RECORD & MEASURED DISTANCE PER R-1

- △ SET GEAR SPIKE & WASHER "LS 5411" PER TIES ON R-1, FLUSH, AFTER CONSTRUCTION.
- FD. NAIL & TAG "RCE 8793" IN T.C. PER R-1.
- FD. NAIL & TAG "LS 8294" IN T.C. PER R-1.
