CORNER RECORD

Document Number 2006-1168BCity of UNINCORPORATED AREA County of ORANGE, CaliforniaBrief Legal Description PROSPECT AVENUE AT RAINIER DRIVE

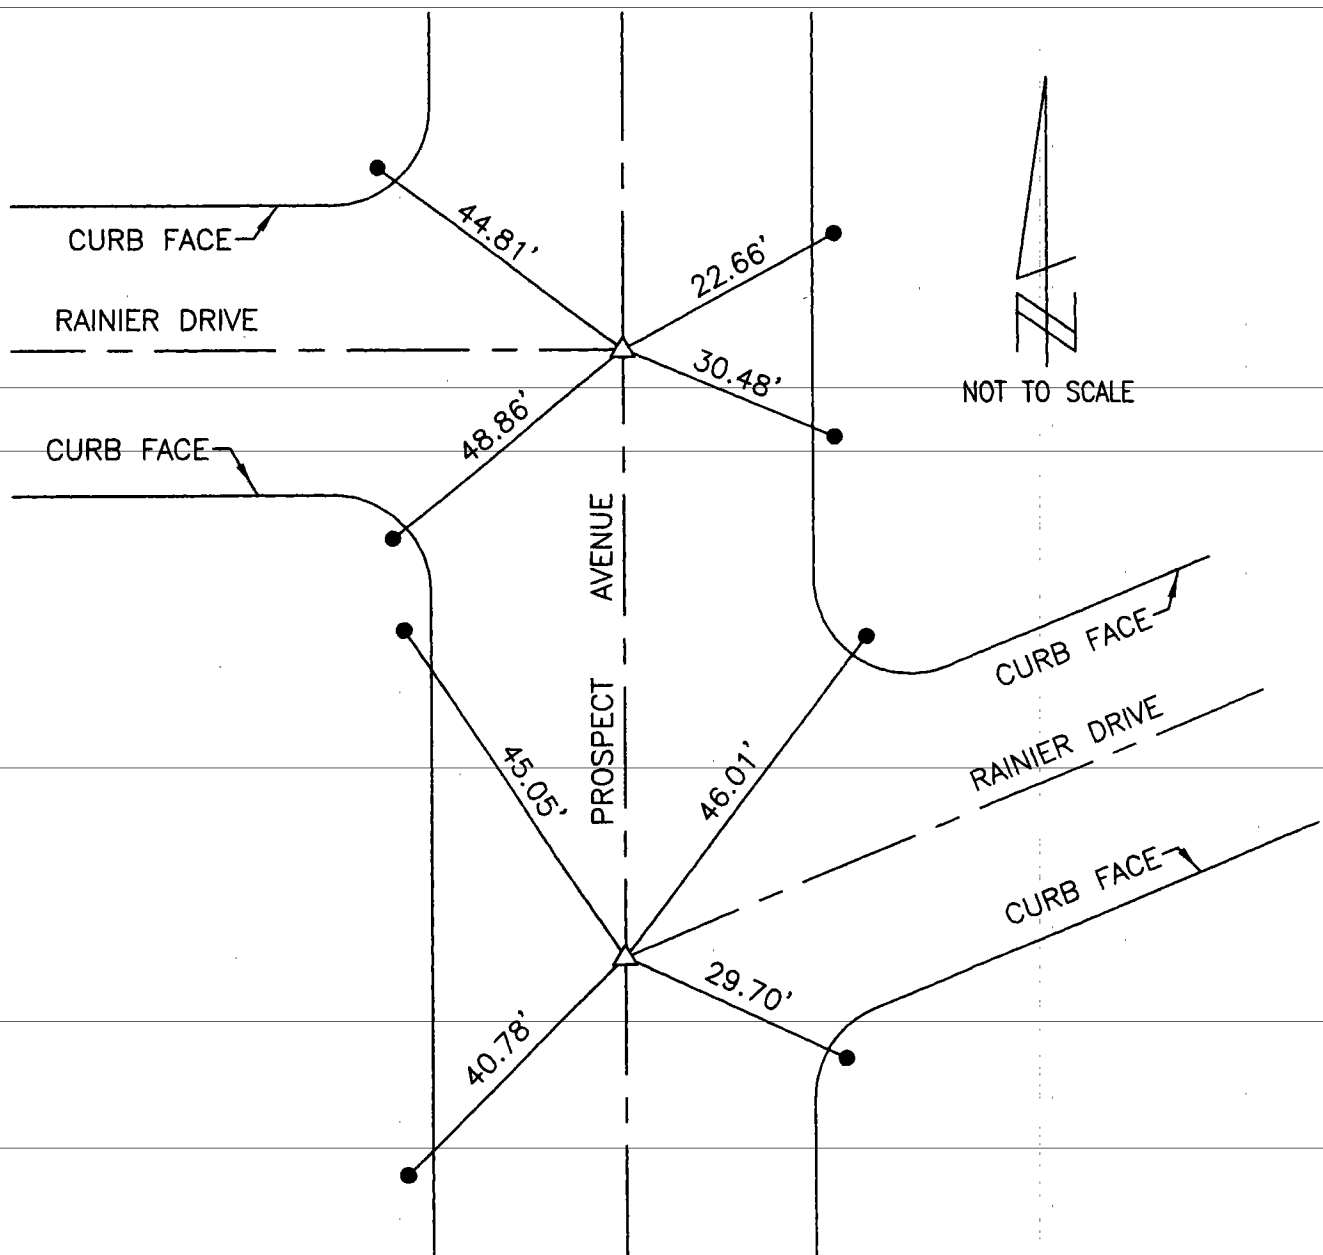
- △ SET SPIKE AND WASHER LS 7052, PER CORNER RECORD 2005-1253A, AFTER STREET RECONSTRUCTION.
- FOUND LEAD AND OCS TIE TAG IN TC, PER CORNER RECORD 2005-1253A, AFTER STREET RECONSTRUCTION.

THE TIES SHOWN HEREON ARE FOR THE PURPOSE OF PERPETUATING THE MONUMENTATION CURRENTLY EXISTING. NO ATTEMPT WAS MADE TO DETERMINE THE VALIDITY OF THE MONUMENTS OR THEIR PROPER LOCATION IN RELATION TO LEGAL BOUNDARY LINES IN THE AREA.

Identification and type of corner found: Evidence used to identify or procedure used to establish or reestablish the corner:
ESTABLISHED MONUMENTATION AS DESCRIBED ON PAGE 2.

A description of the physical condition of the monument as found and as set or reset: AFTER STREET
RECONSTRUCTION THE MONUMENTATION SHOWN ON PAGE 2 WAS REESTABLISHED.
