CORNER RECORD

Document Number 2014-3045BCity of TUSTIN County of ORANGE, CaliforniaBrief Legal Description SANTA CLARA AVENUE & FAIRMONT WAY (S)

14-RJN-521

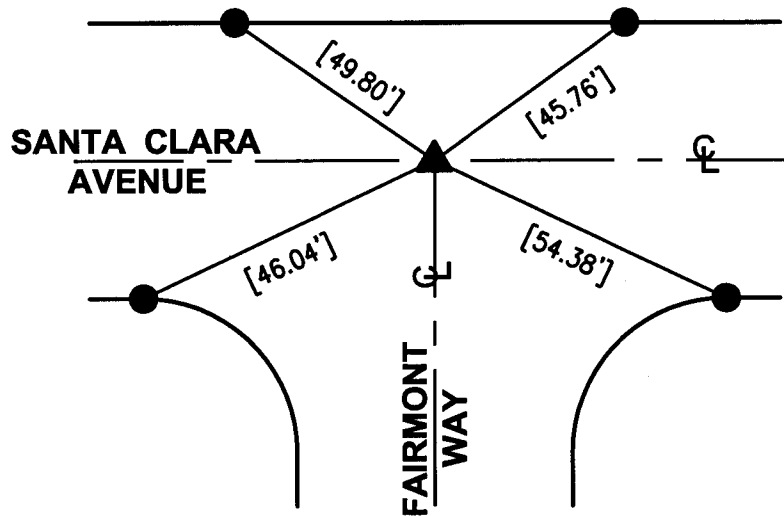
R-1 = COUNTY OF ORANGE CORNER RECORD 2014-1852 A
 [] = RECORD & MEASURED DISTANCE PER R-1

▲ FD SMALL NAIL IN CONCRETE IN O.C.S. WELL MON PER R-1, DOWN 1.5', AFTER CONSTRUCTION.

● FD L, T & T "CALTRANS" IN T.C. PER R-1.
