CORNER RECORD

Document Number 2015-2276BCity of TUSTIN County of ORANGE, CaliforniaBrief Legal Description MALTA STREET & SPAULDING AVENUE

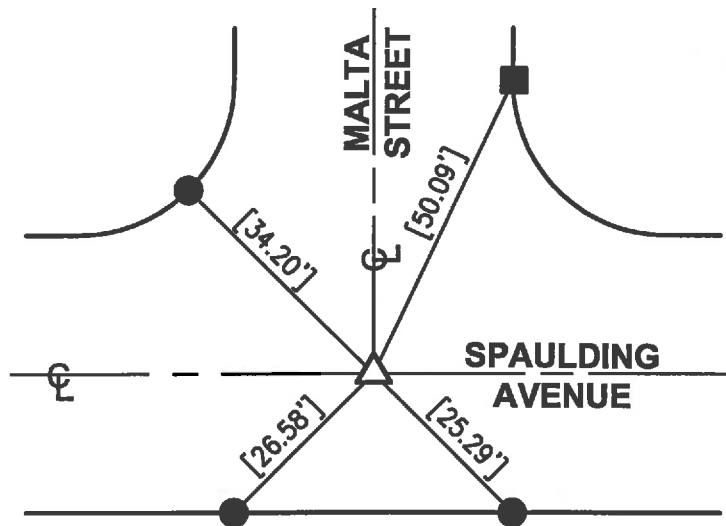
N.T.S.

R-1 = COUNTY OF ORANGE CORNER RECORD 2015-2223 A

[] = RECORD & MEASURED DISTANCE PER R-1

△ SET GEAR SPIKE & WASHER "LS 5411" PER TIES ON R-1, FLUSH, AFTER CONSTRUCTION.

● FD. LEAD, TACK & TAG "OCS TIE" IN T.C. PER R-1.

■ FD. LEAD, TACK & TAG "LS 5411" IN T.C. PER R-1.
