**GPS #:** **4523R1**

City / Location: Rancho Santa Margarita

**Description:**

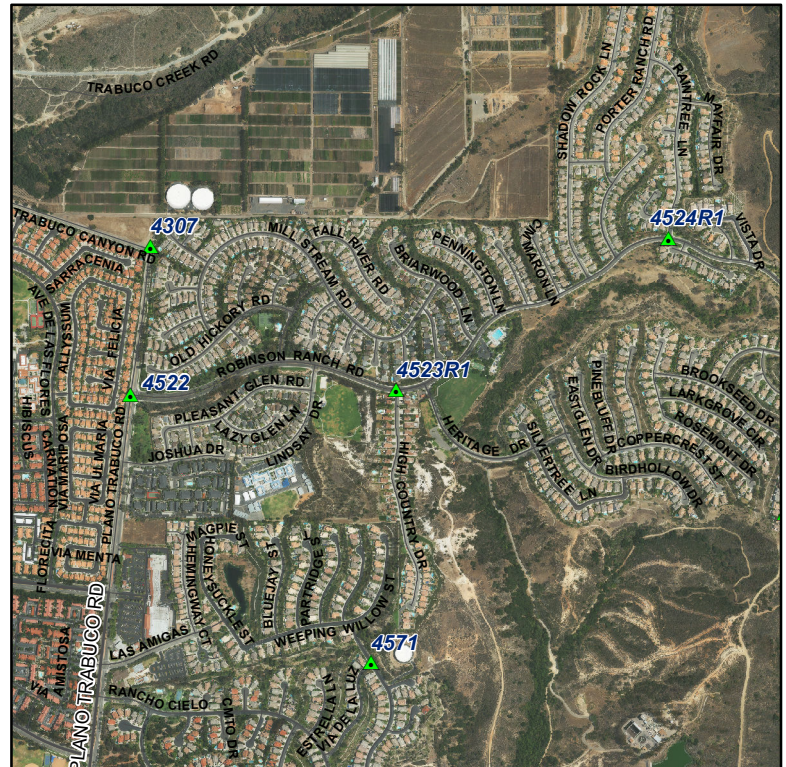
FD GEAR SPIKE AND WASHER STAMPED "LS 5411" PER CR 2014-1970 FLUSH, IN LIEU OF GEAR SPIKE AND ALUMINUM TAG STAMPED "RCE 23956" DOWN 0.2' IN A.C., AT THE CENTERLINE INTER OF ROBINSON RANCH RD. AND HIGH COUNTRY DR.
