**GPS #:** **4527R1**

City / Location: Rancho Santa Margarita

**Description:**

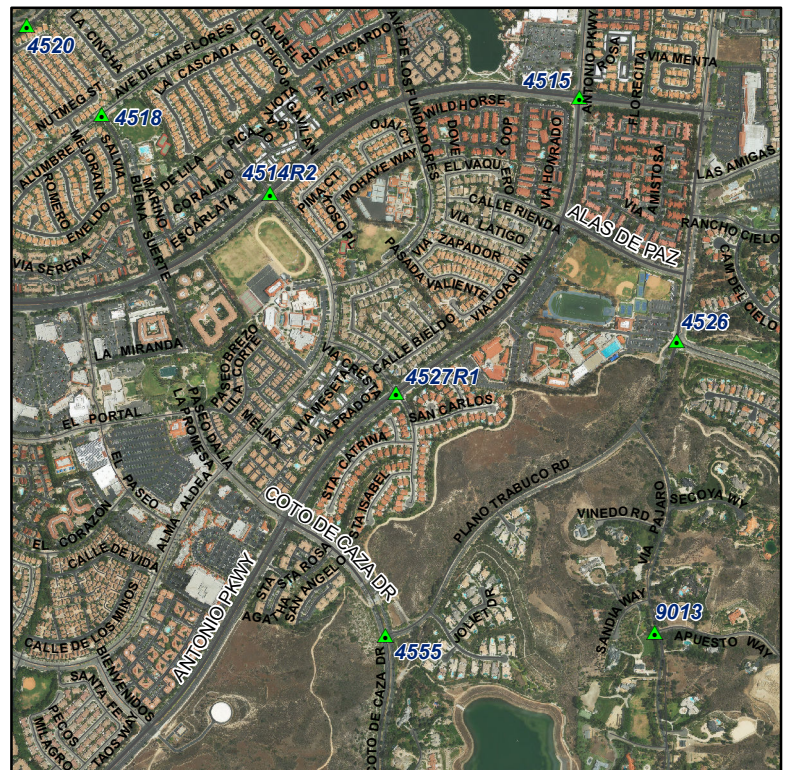
FD GEAR SPIKE AND WASHER STAMPED "LS 5411"  
FLUSH PER CR 2012-3205, IN LIEU OF PUNCHED  
BOLT AND BRASS WASHER STAMPED "LS 3246"  
FLUSH IN A.C. SURFACE, AT THE CENTERLINE  
INTER OF ANTONIO PKWY. AND VIA HONESTO.
