**GPS #:** **5190R1**

City / Location: Yorba Linda

**Description:**

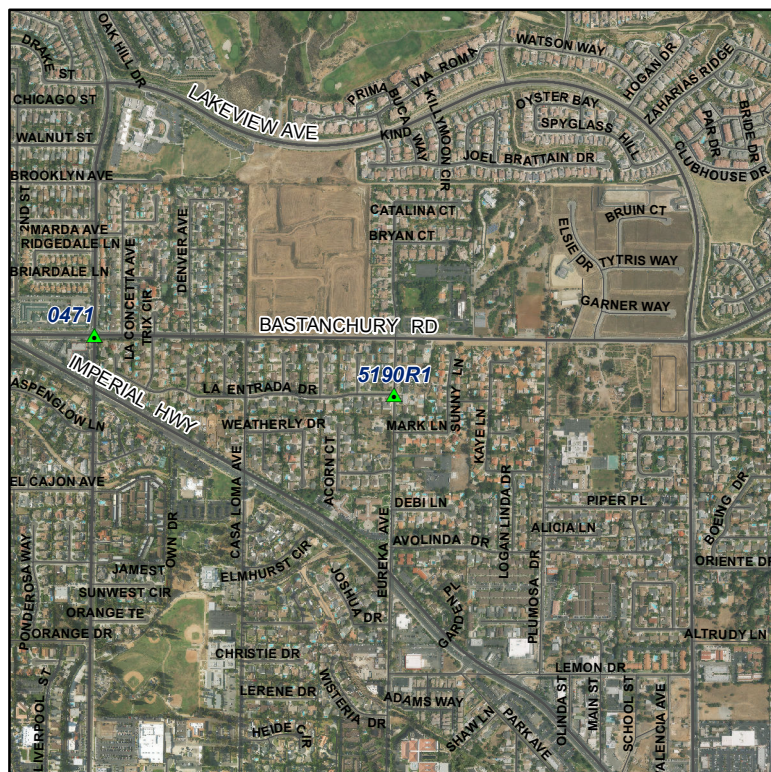
FD GEAR SPIKE WITH WASHER STAMPED "LS 5411", FLUSH, PER CR 2012-0621 IN LIEU OF, PUNCHED SPIKE AND WASHER AT THE APPARENT CENTERLINE INTER OF LA ENTRADA DR. AND EUREKA AVE.
