## GPS #: PRADO-88-11

City / Location: Prado Basin Area.

References: 2015 Prado Basin GPS Survey.

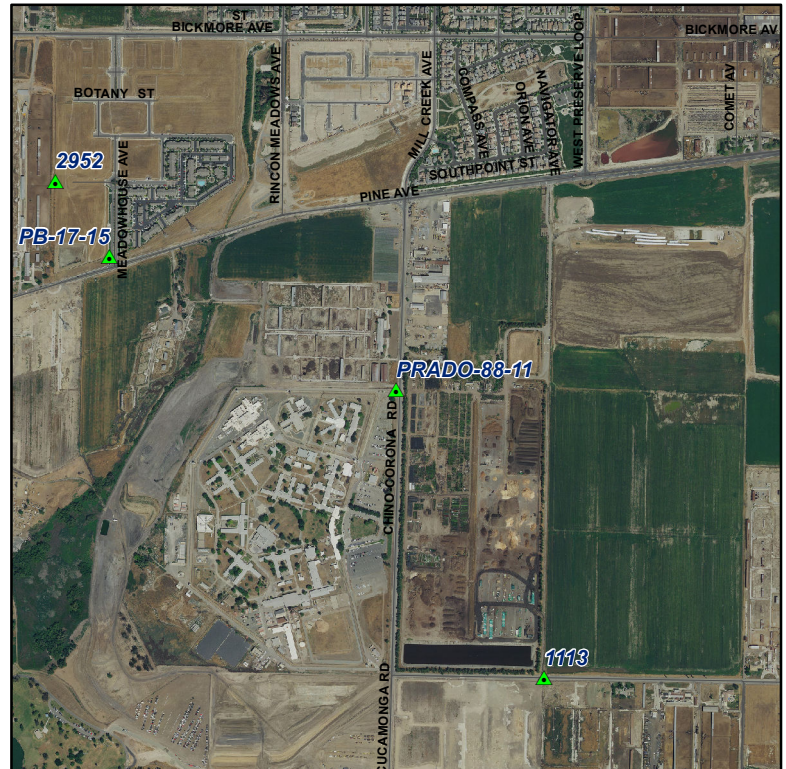
FOUND 3 3/4" OCS ALUMINUM BENCHMARK DISK "PRADO-88-11" SET IN CONCRETE COLLAR. STATION IS LOCATED ALONG THE W'LY SIDE OF CHINO-CORONA ROAD 0.3 MILES S'LY OF PINE AVE. NEAR THE NE'LY CORNER OF THE WOMEN'S REHABILITATION CENTER. 30.6' W'LY OF THE CENTERLINE CHINO-CORONA ROAD, 4.2' W'LY OF P.P. #4019018E.
