**GPS #:** **SPILLWAY**

City / Location: Prado Basin Area.

References: 2015 Prado Basin GPS Survey.

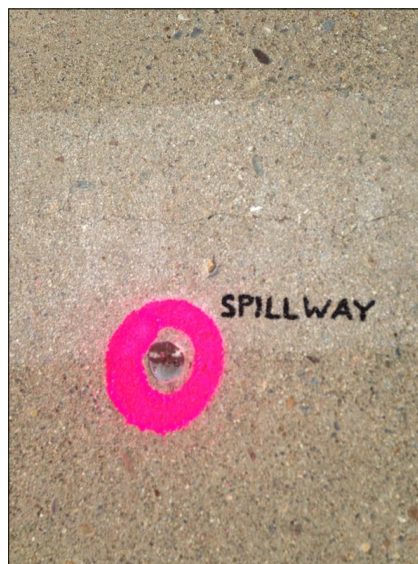
FOUND LEAD AND TACK IN TOP CENTER OF  
SPILLWAY STRUCTURE SE'LY OF MAIN DAM.
