Orange County Bridge Review Summary

Bridge Number: 55C0017

Bridge Name: Santa Ana River Channel

Facility Carried: Lincoln Avenue

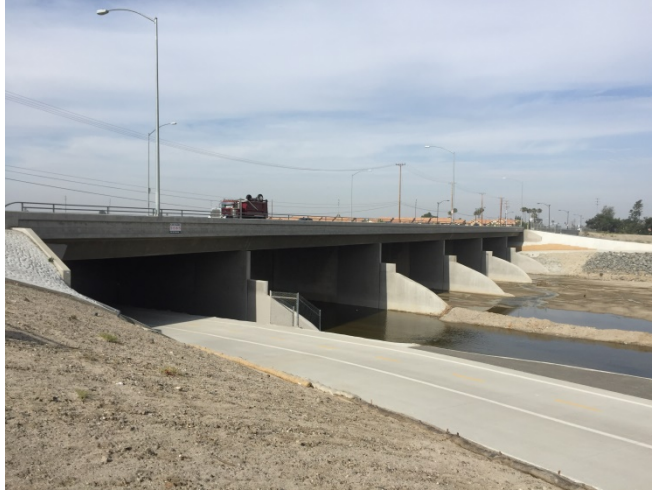
Photo 1:

- Concrete at joint is spalling and small portion of joint seal bulging (photo 1). No action required at this time.
- Some efflorescence visible on soffit (photo 2). Deck appeared to be treated. No immediate action required. But the bridge soffit should continue to be monitored to determine if water is seeping through the bridge deck.

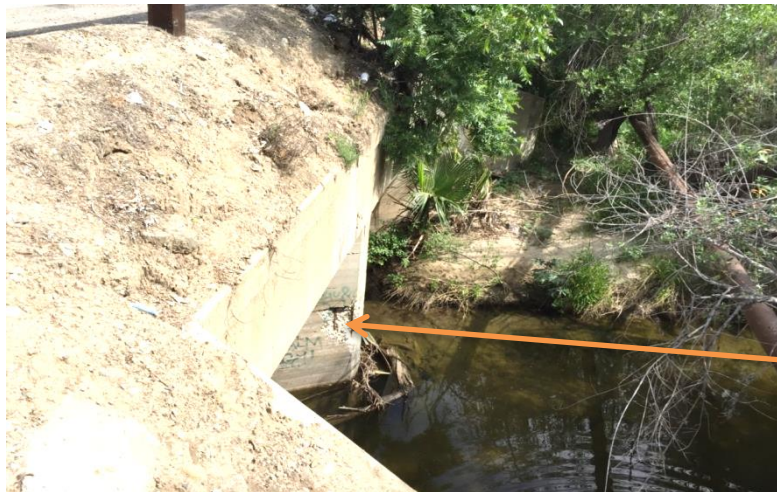
Photo 2: Bridge Pier

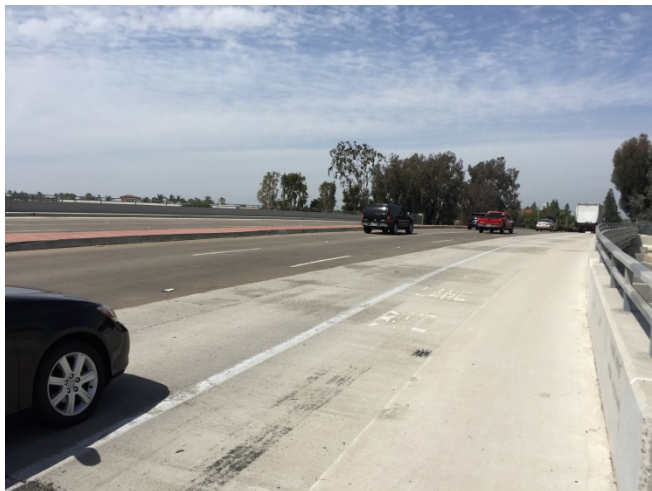
Efflorescence

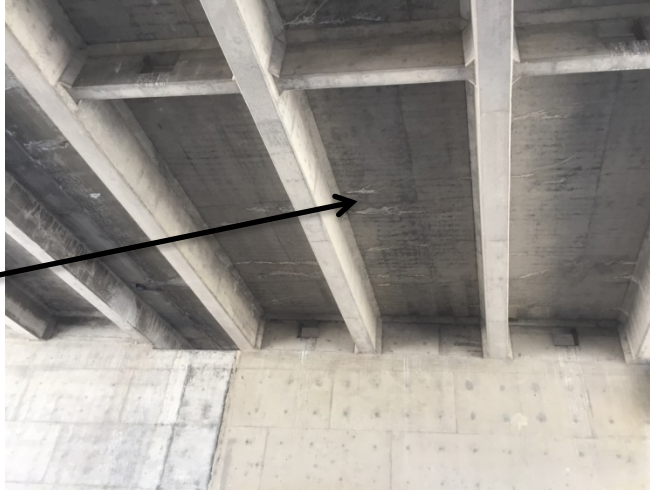
Photo 4: Bridge Soffit

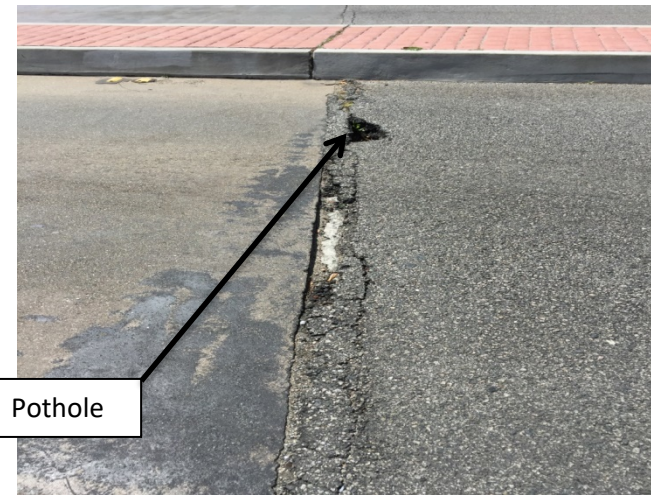
Pothole

Photo 5: Bridge Approach

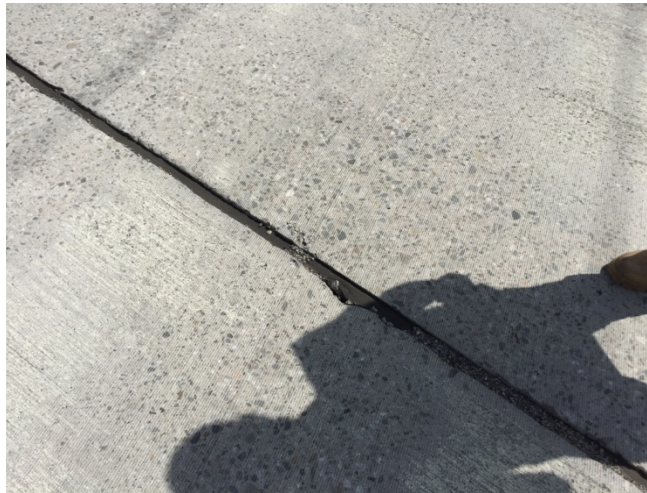
Photo 5: Joint Seal

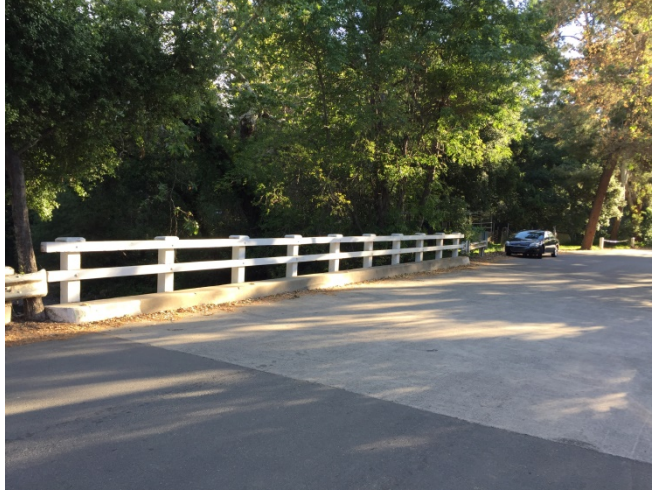
Photo 1: Santiago Creek Bridge

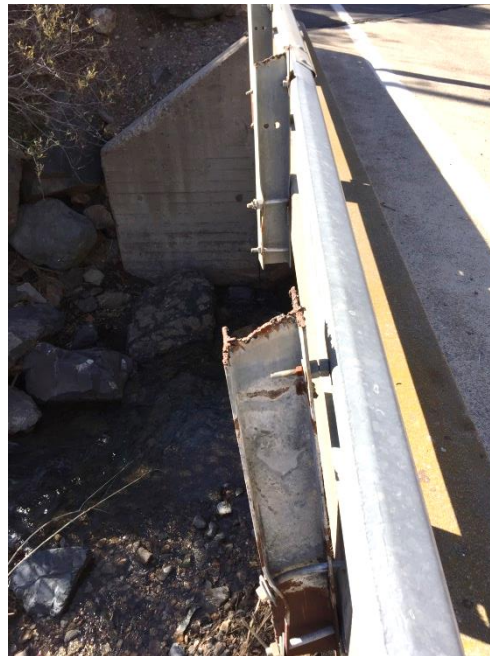
Photo 8: Broken Post

- Repair Damaged Railing ≈ \$15,000.

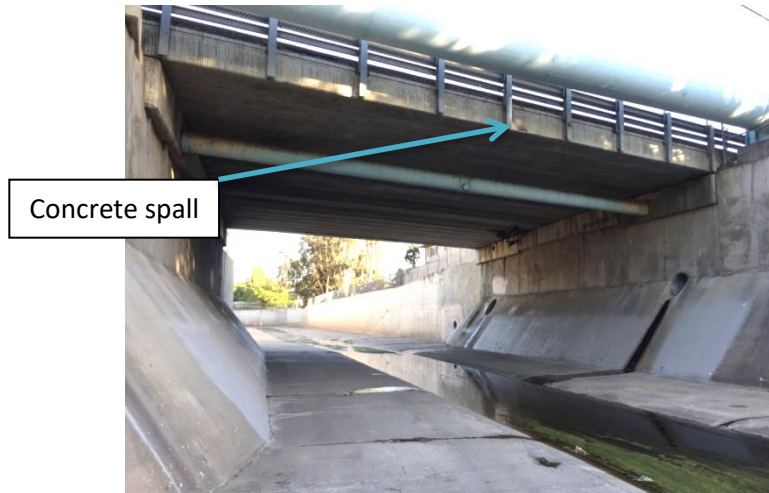
Photo 4: Elevation View

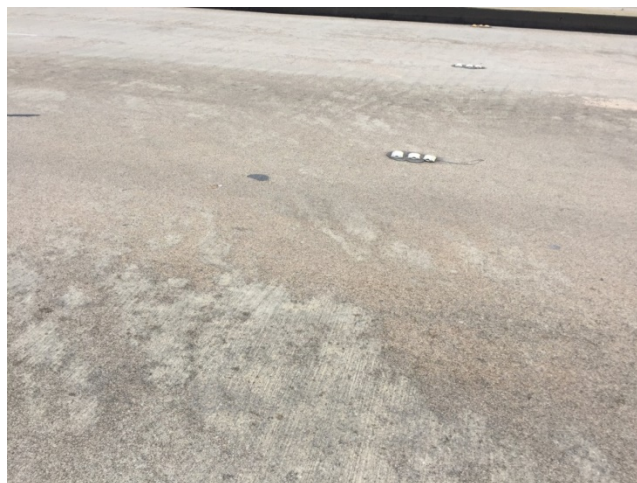
Photo 3: Bridge Deck

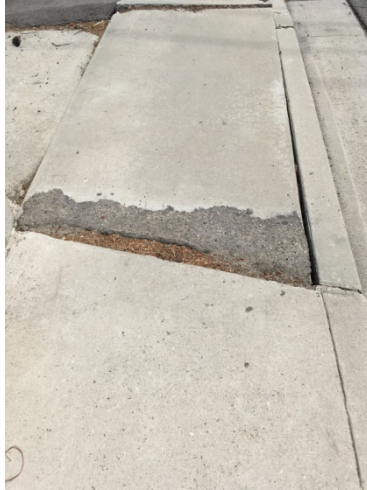
- Exposed rebar in barrier at several locations. (photo 6) Recommend patching spalled concrete.
- Torn joint seal (photo 5).
- Uneven sidewalk at bridge approach (photo 7).
- Bridge deck appears to be treated.
- Efflorescence on bridge soffit. OCPW stated the bridge deck has been treated.

Photo 7: Sidewalk

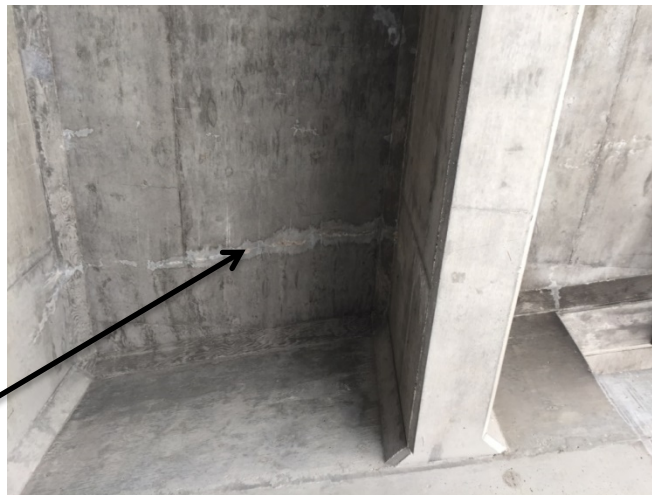
Photo 8:

Efflorescence

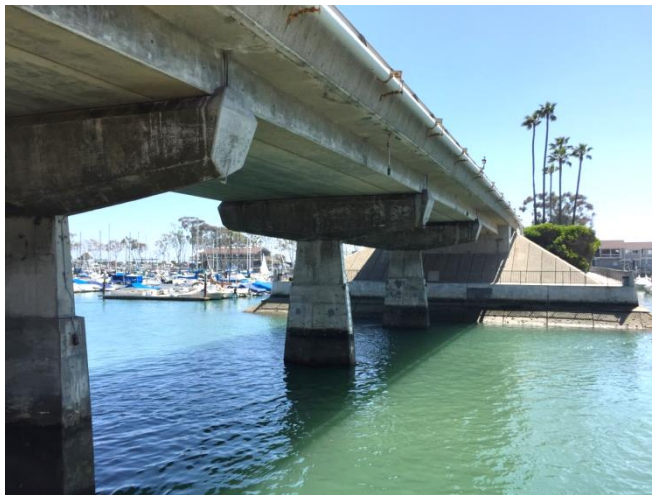
Photo 1:

- Minor spalling on walkway
- There was minimal access to the substructure (photo 1 and 2). Overall this bridge appears to be in good condition.
- Joint seals filled with debris. (photo 3) No immediate action required.

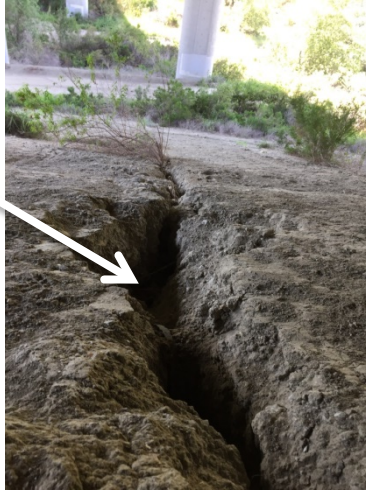
Deep Rutting

Photo 6: Rutting at abutment

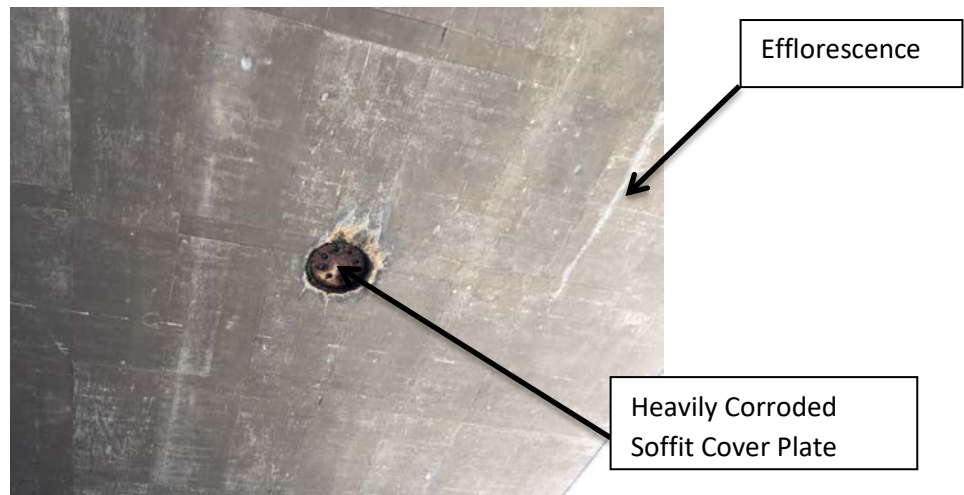
Photo 8: Bridge Soffit

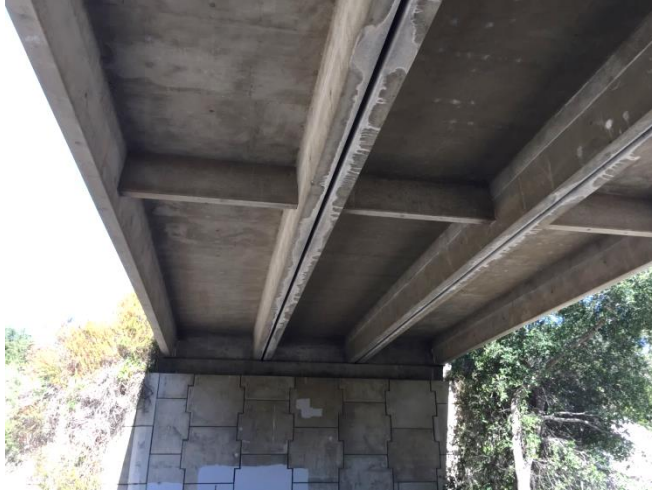
Photo 1: Bridge Soffit

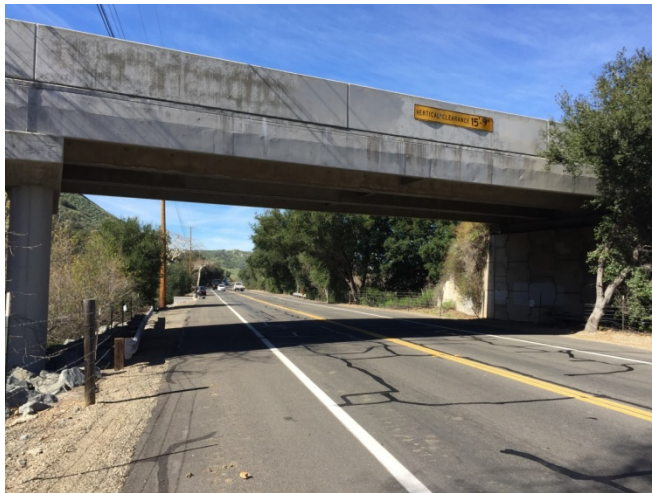
Photo 2: Bridge Elevation

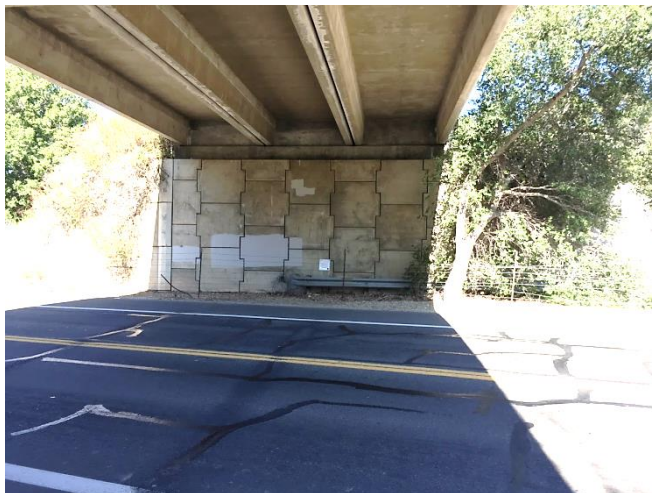
Photo 3: Bridge Abut
